Menasha Lock and Dam

HAER No. WI-90

**At the confluence of Lake Butte Des Morts
and the Lower Fox River, in the City of Menasha**

WRITTEN HISTORICAL AND DESCRIPTIVE DATA

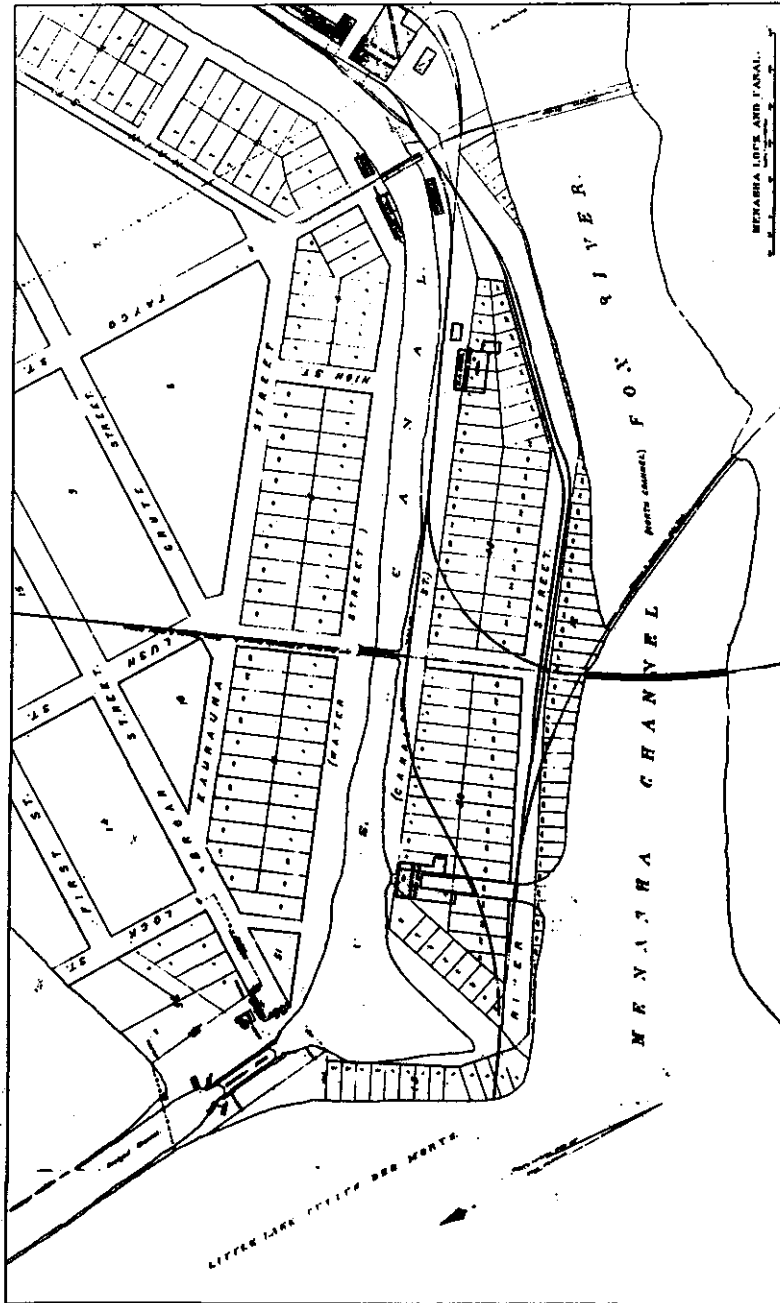
Photocopy of drawing of Menasha Lock and Canal, as drawn by J.W. Beardsley and C.A. Young, 1900, sheet no. 15.

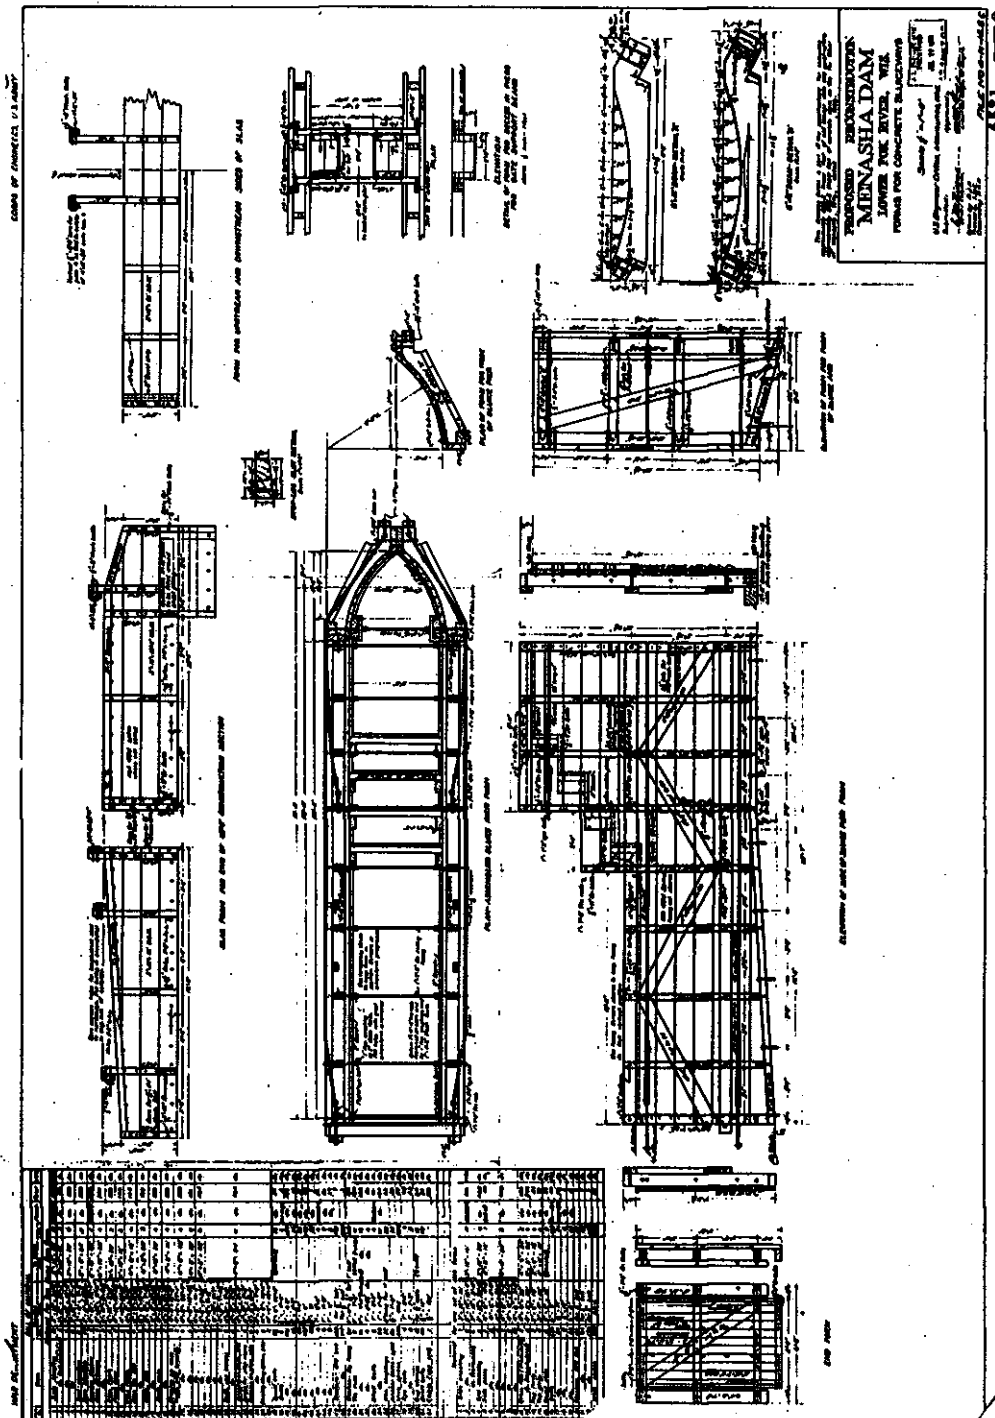
Photocopy of plans of Proposed Reconstruction, Menasha Dam, Forms for Concrete Sluiceways, USACOE File No. 4521, File No. 4-N-15.5 C.

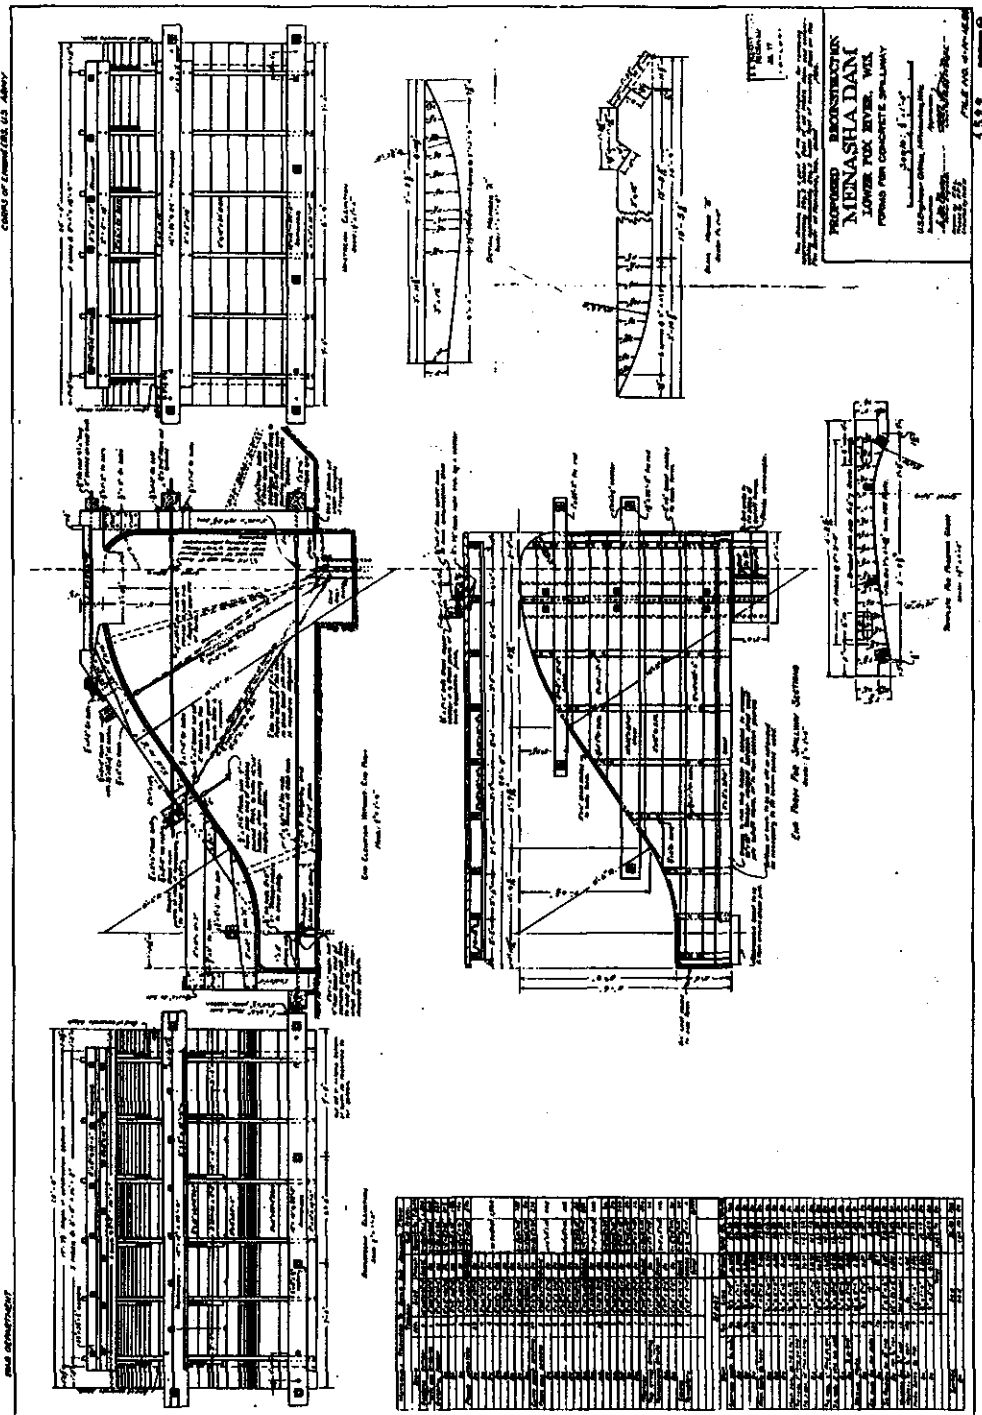
Photocopy of plans of Proposed Reconstruction, Menasha Dam, Forms for Concrete Spillway, USACOE File No. 4522, File No. 4-N-15.5 D.

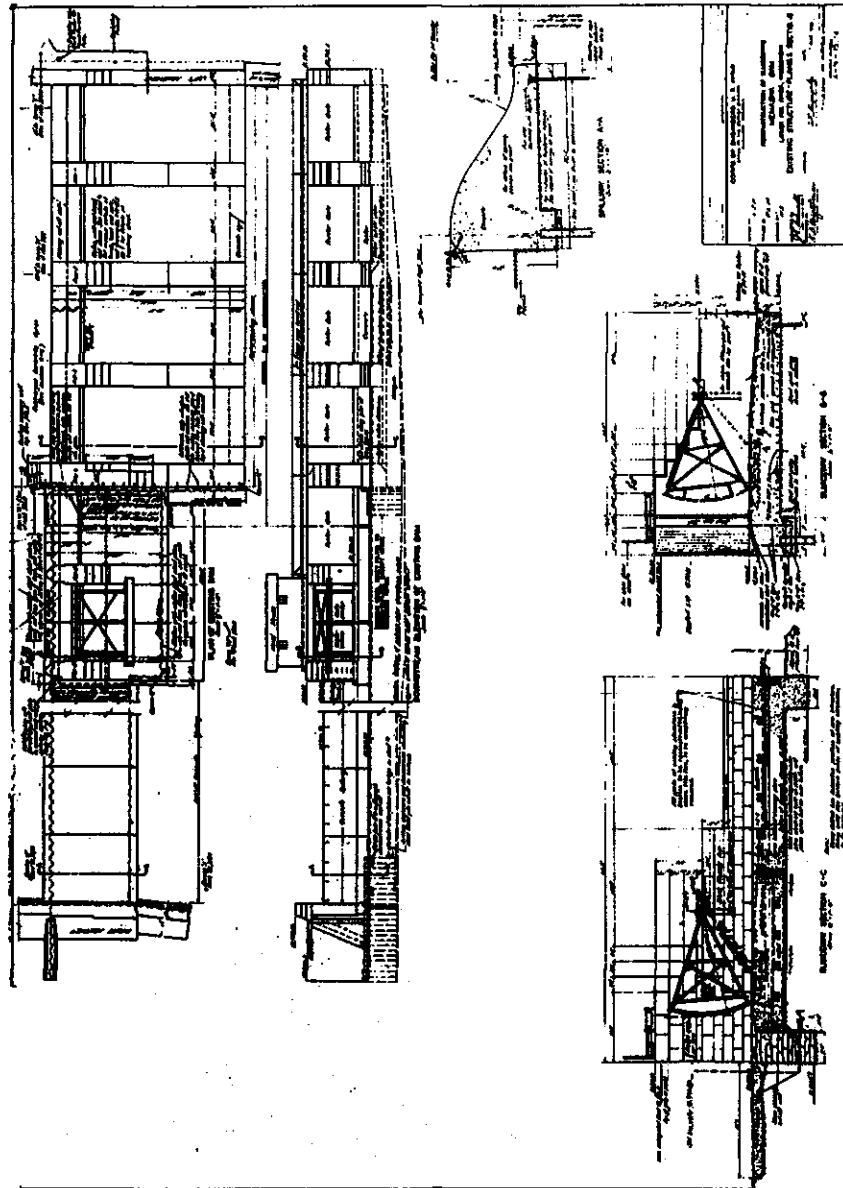
Photocopy of plans of Reconstruction of Sluiceways, Menasha Dam, Existing Structure - Plans and Sections, File No. 4-N-15.14, sheet 2.

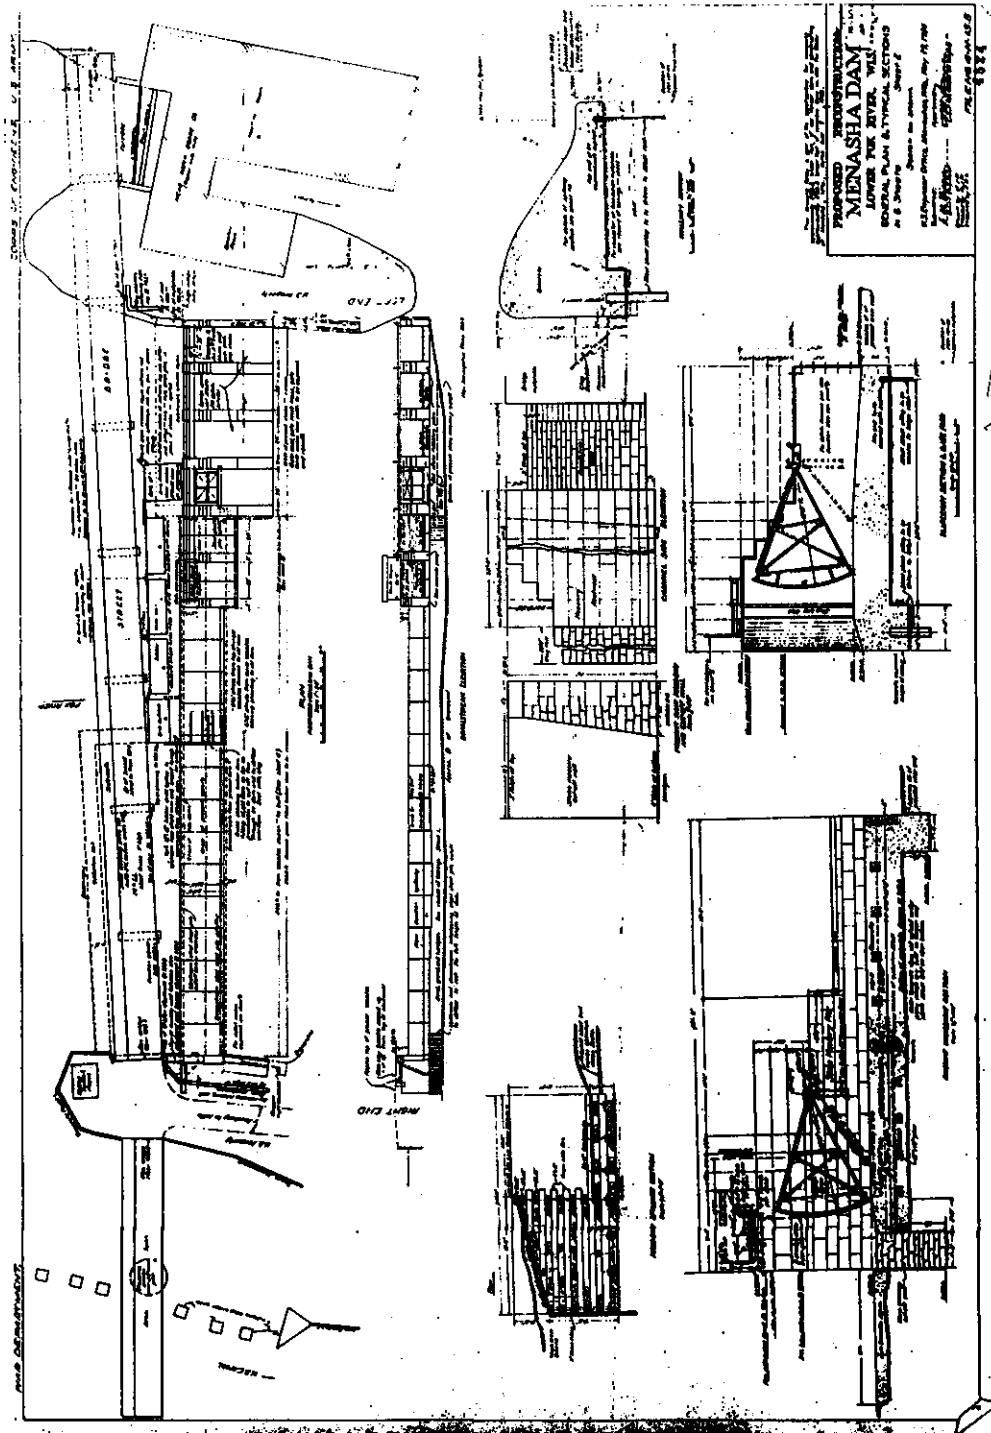
Photocopy of plans of Proposed Reconstruction, Menasha Dam, General Plan and Typical Sections, 1936, File #4-N-15.5, sheet 2.

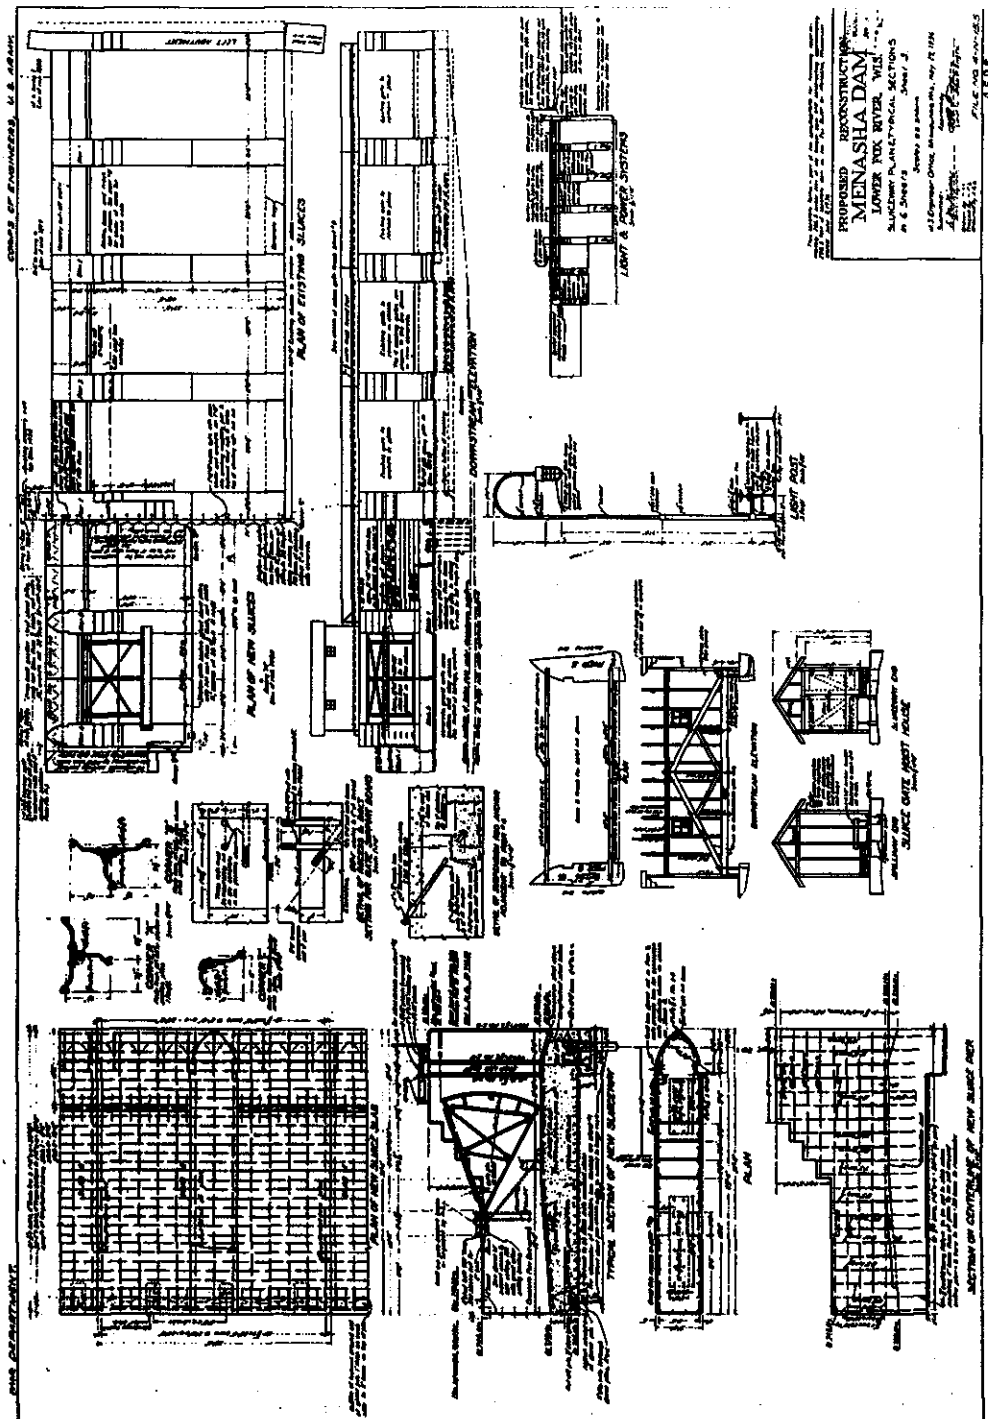
Photocopy of plans of Proposed Reconstruction, Menasha Dam, Sluiceway Plan and Typical Sections, 1936, File #4-N-15.5, sheet 3.

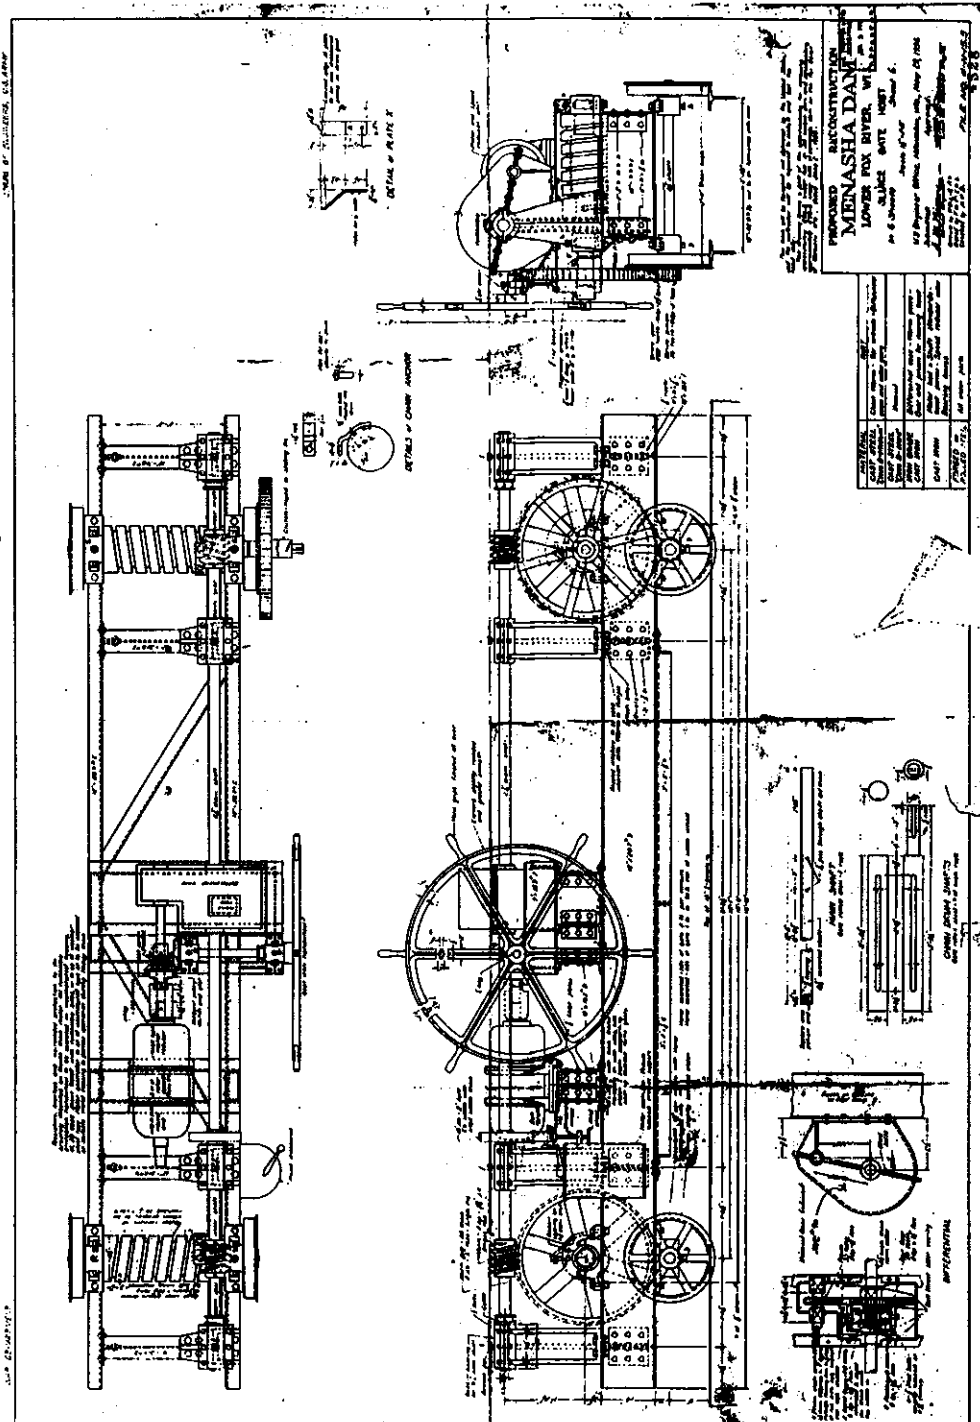
Photocopy of plans of Proposed Reconstruction, Menasha Dam, Sluice Gate Hoist, 1936, File #4-N-15.5, sheet 6.

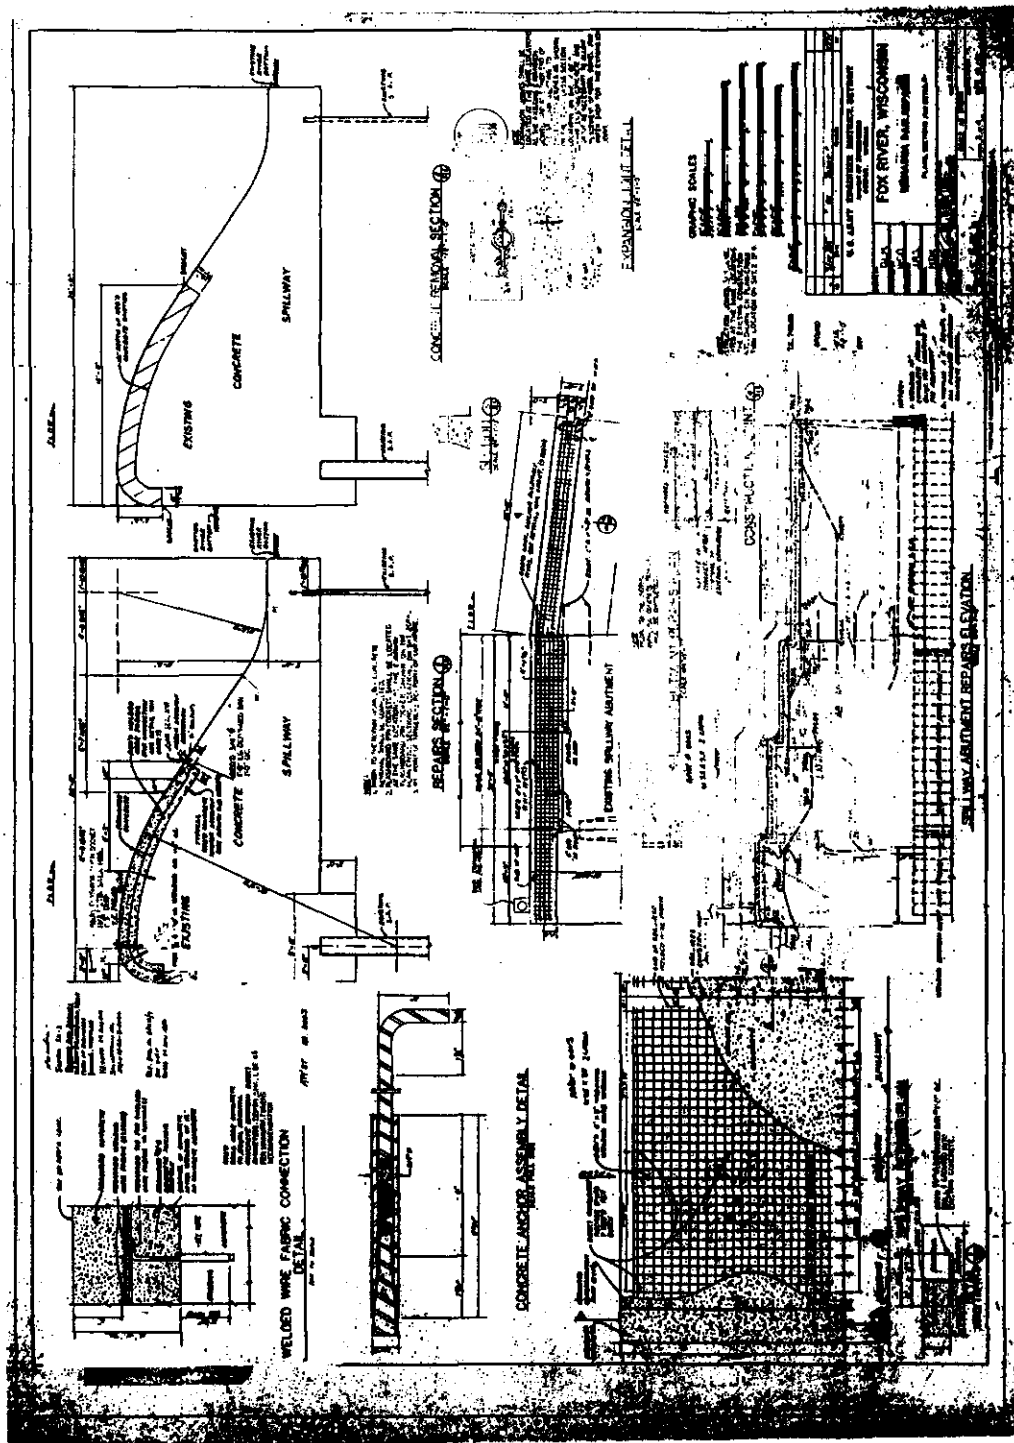
Photocopy of plans of Menasha Dam Repairs, Plans, Sections and Details, 1984, DFX 10/9, sheet 3.

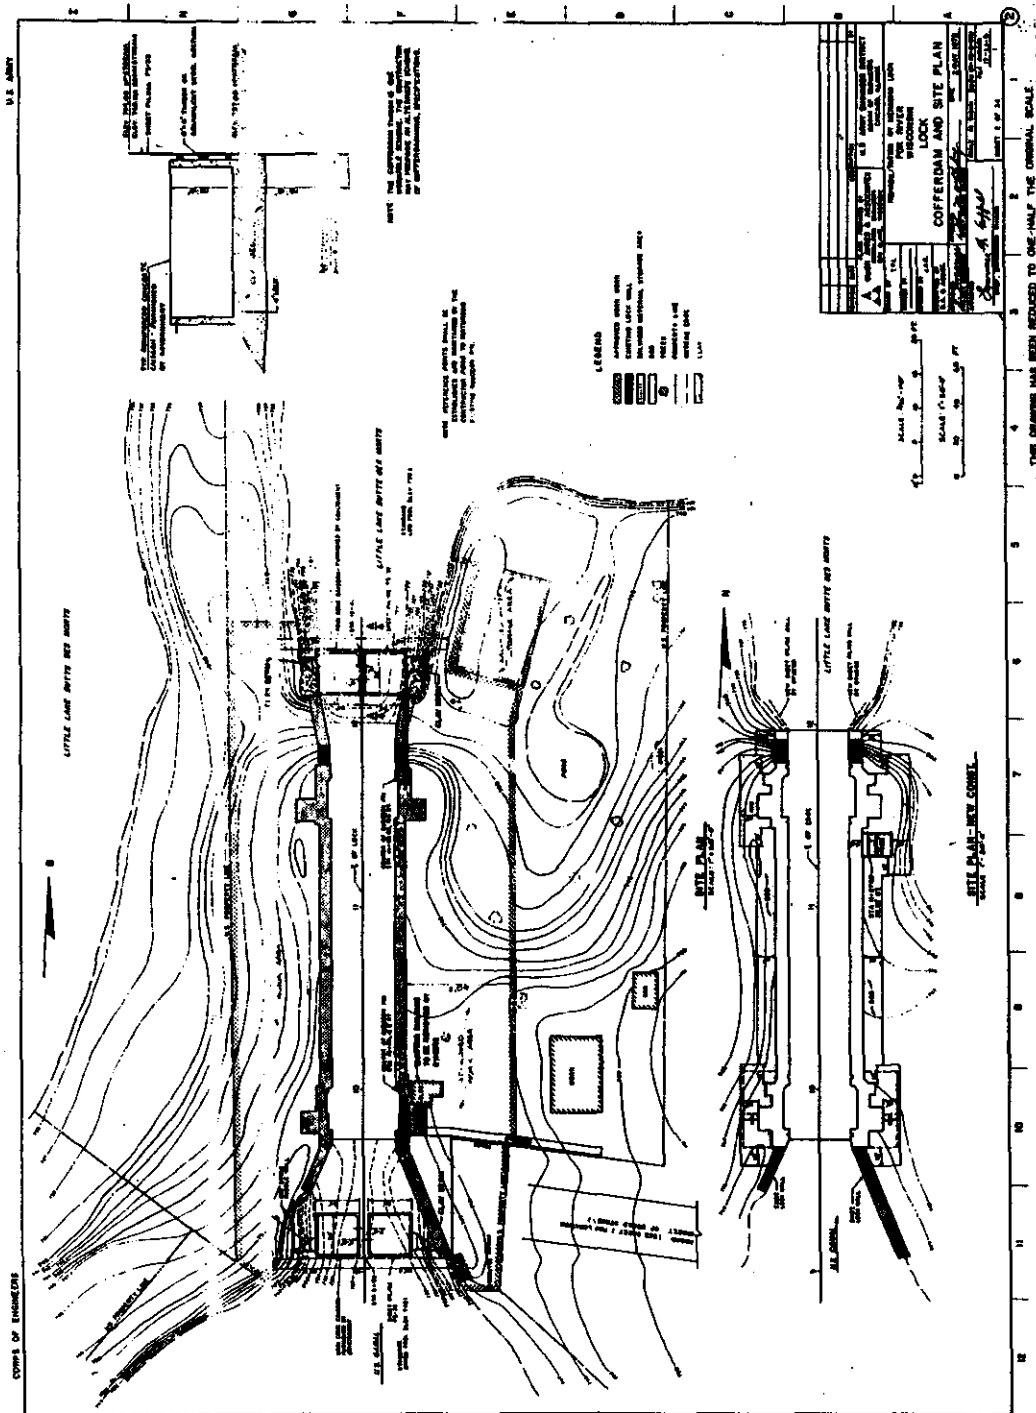
Photocopy of plans for Rehabilitation of Menasha Lock, Lock, Cofferdam and Site Plan, 1978, File #17-L1-9, sheet 2.

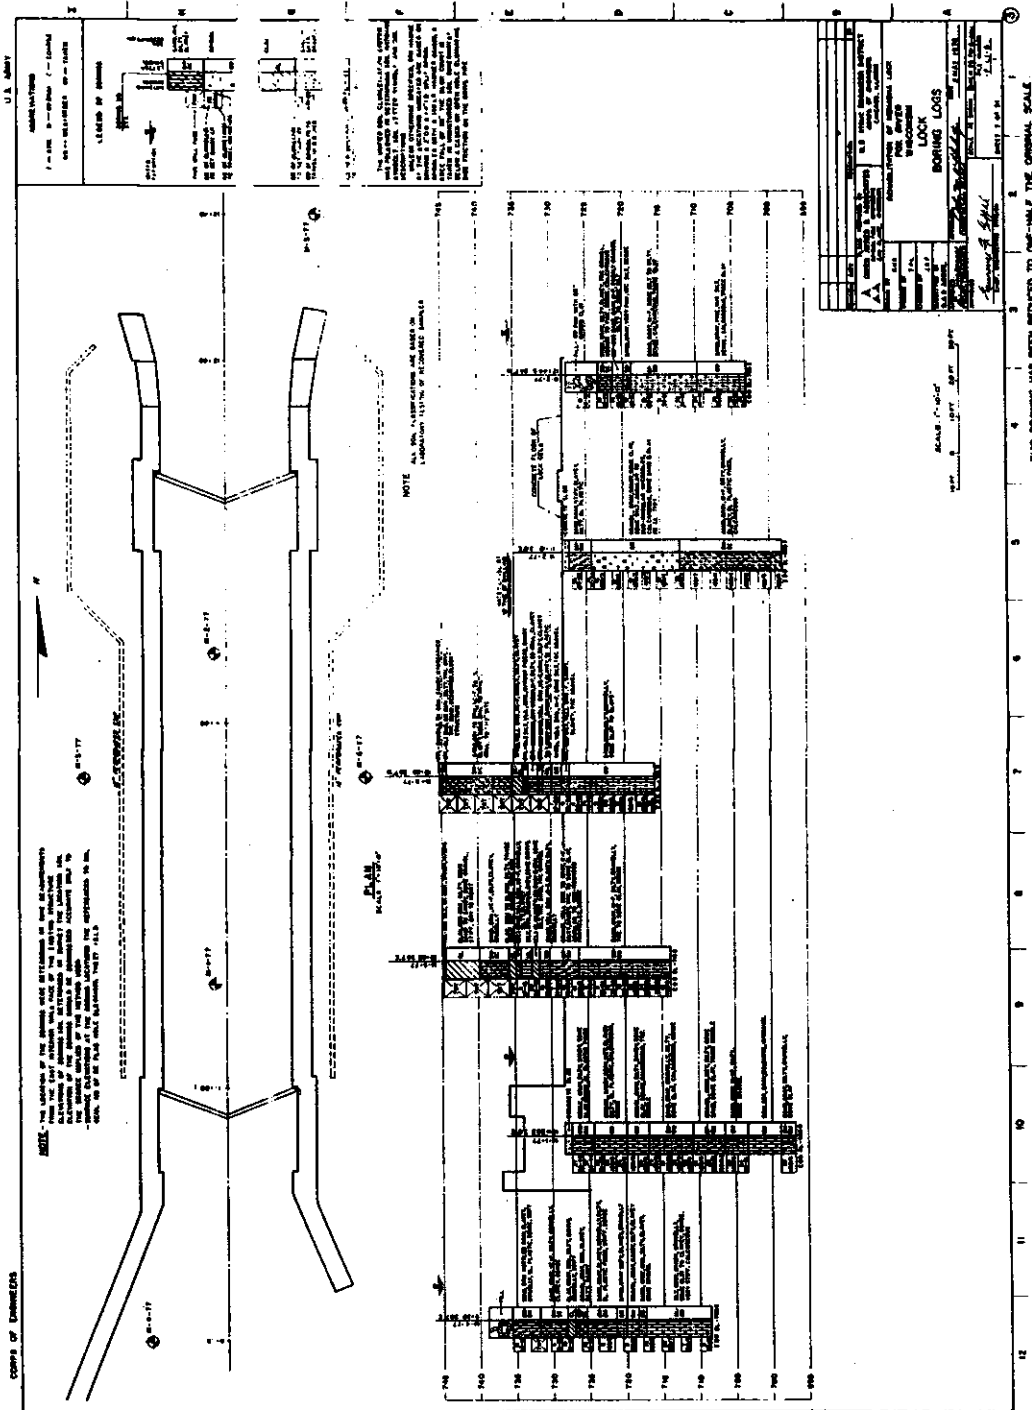
Photocopy of plans for Rehabilitation of Menasha Lock, Lock, Boring Logs, 1978, File #17-L1-9, sheet 3.

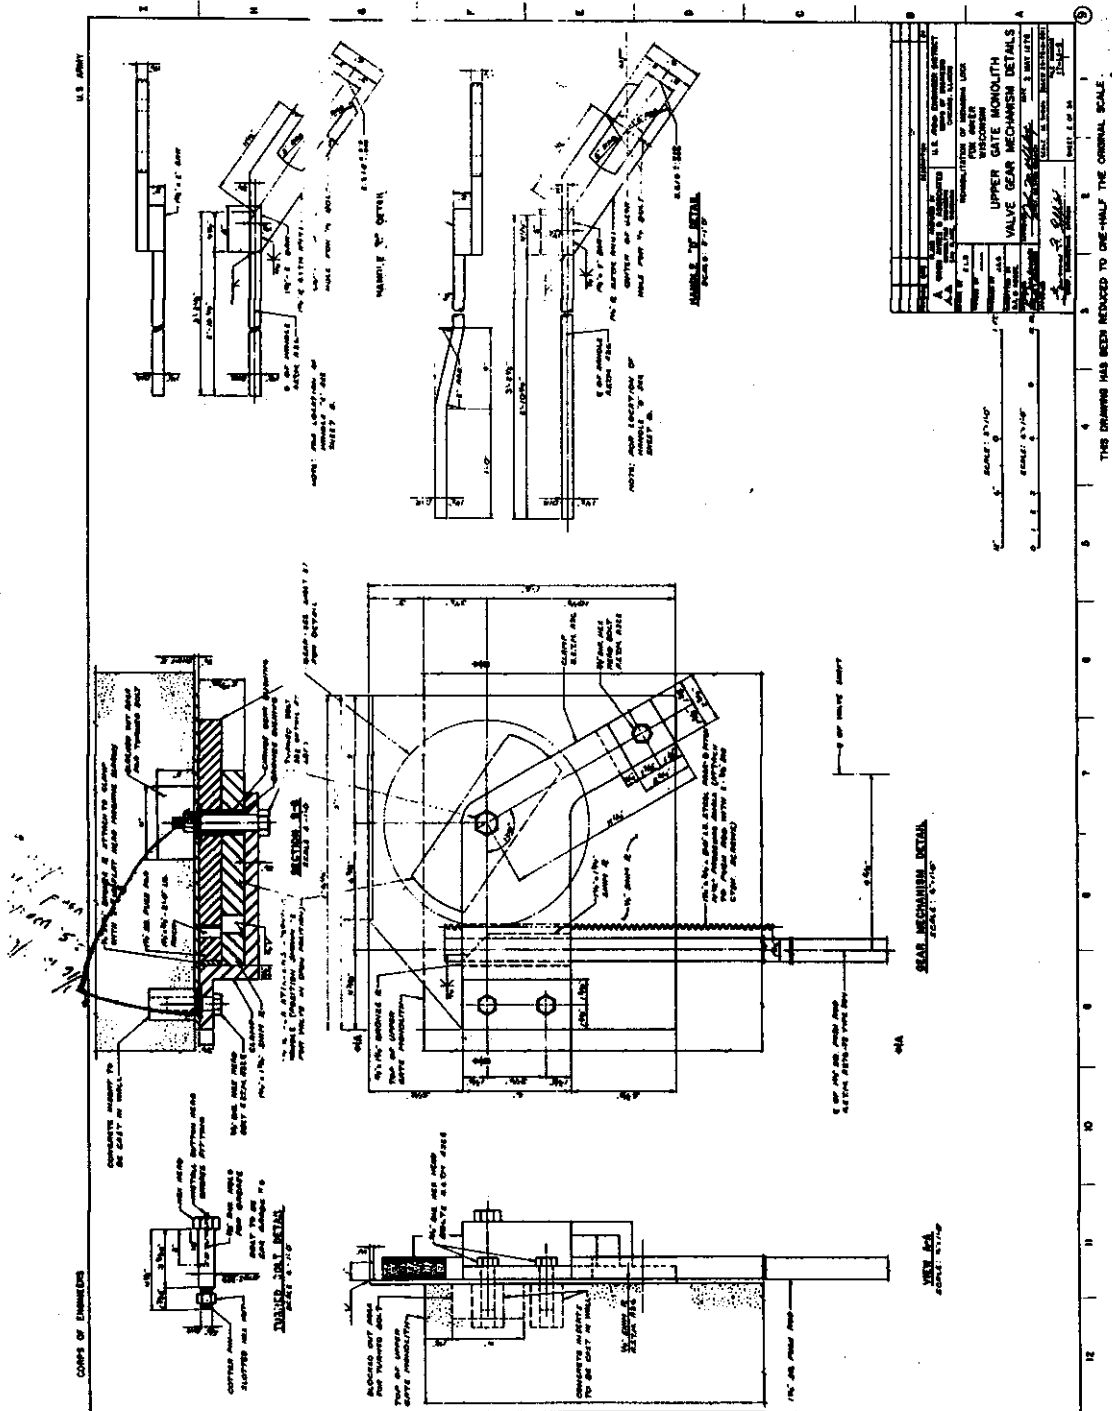
Photocopy of plans for Rehabilitation of Menasha Lock, Upper Gate Monolith, Valve Gear Mechanism Details, 1978, File #17-L1-9, sheet 9.

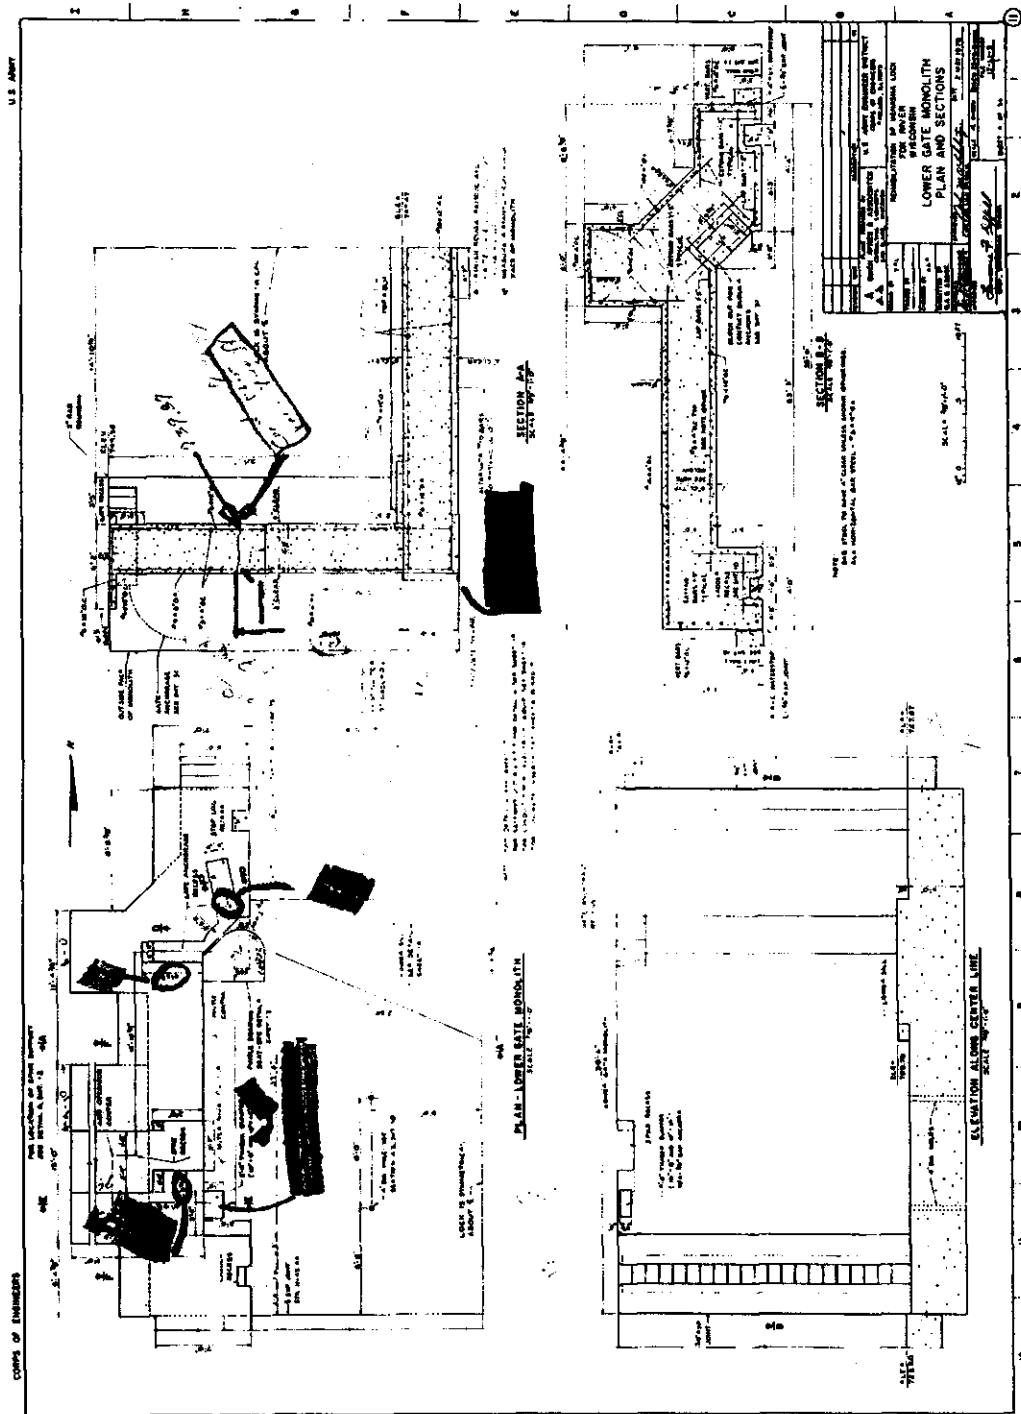
Photocopy of plans for Rehabilitation of Menasha Lock, Lower Gate Monolith, Plan and Sections, 1978, File #17-L1-9, sheet 11.

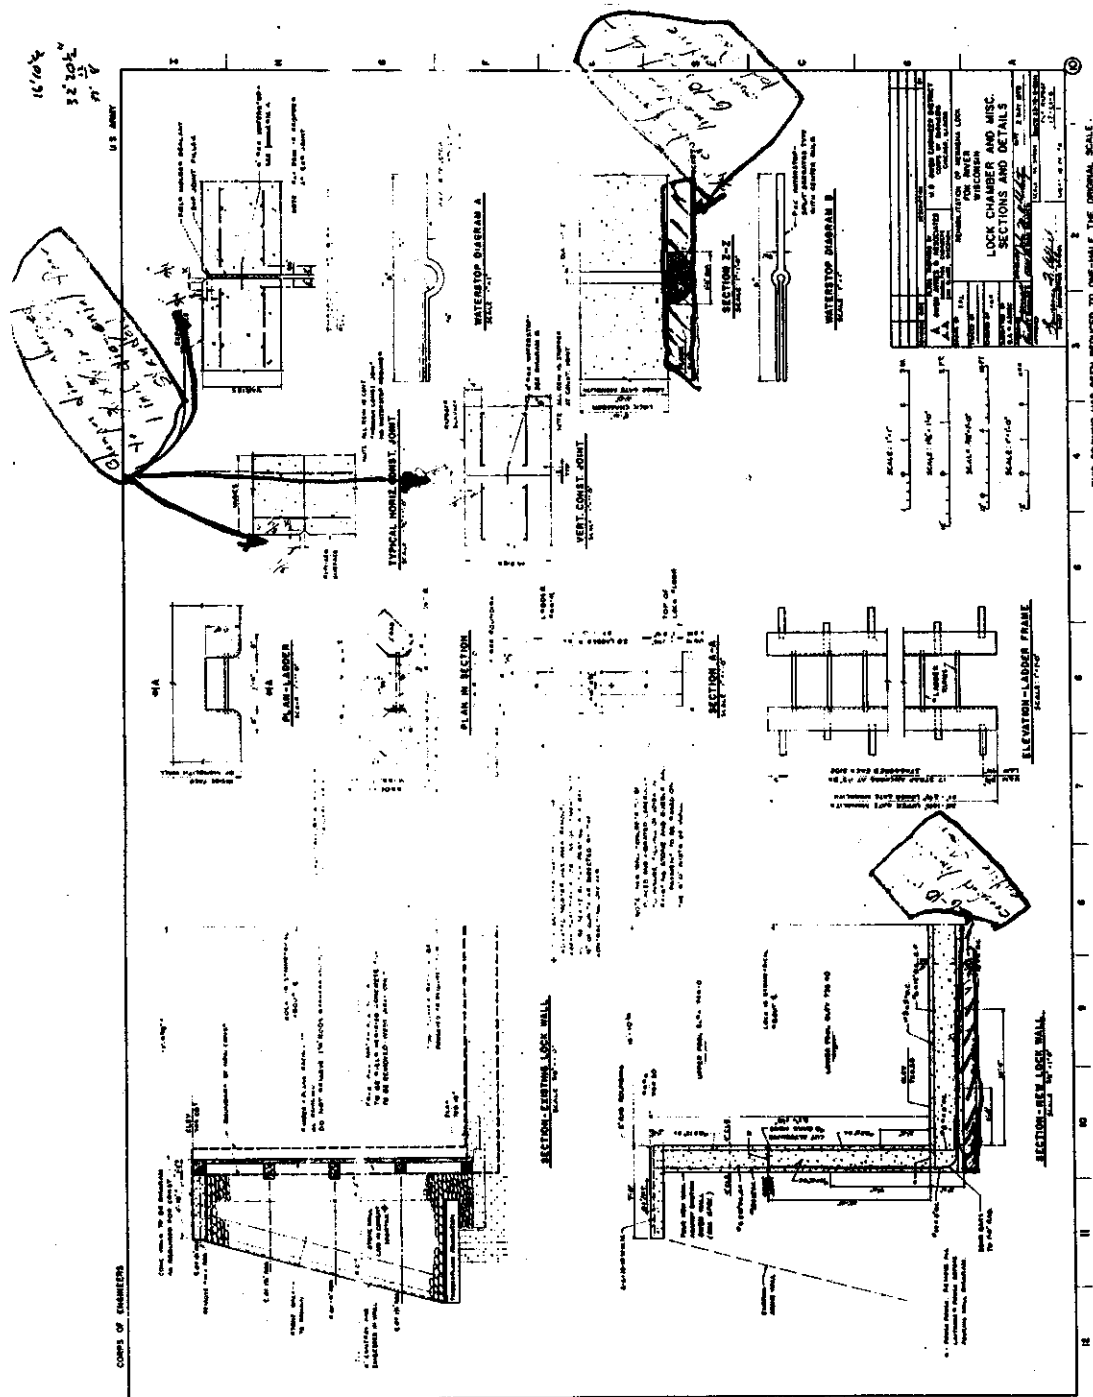
Photocopy of plans for Rehabilitation of Menasha Lock, Lock Chamber and Misc., Sections and Details, 1978, File #17-L1-9, sheet 10.

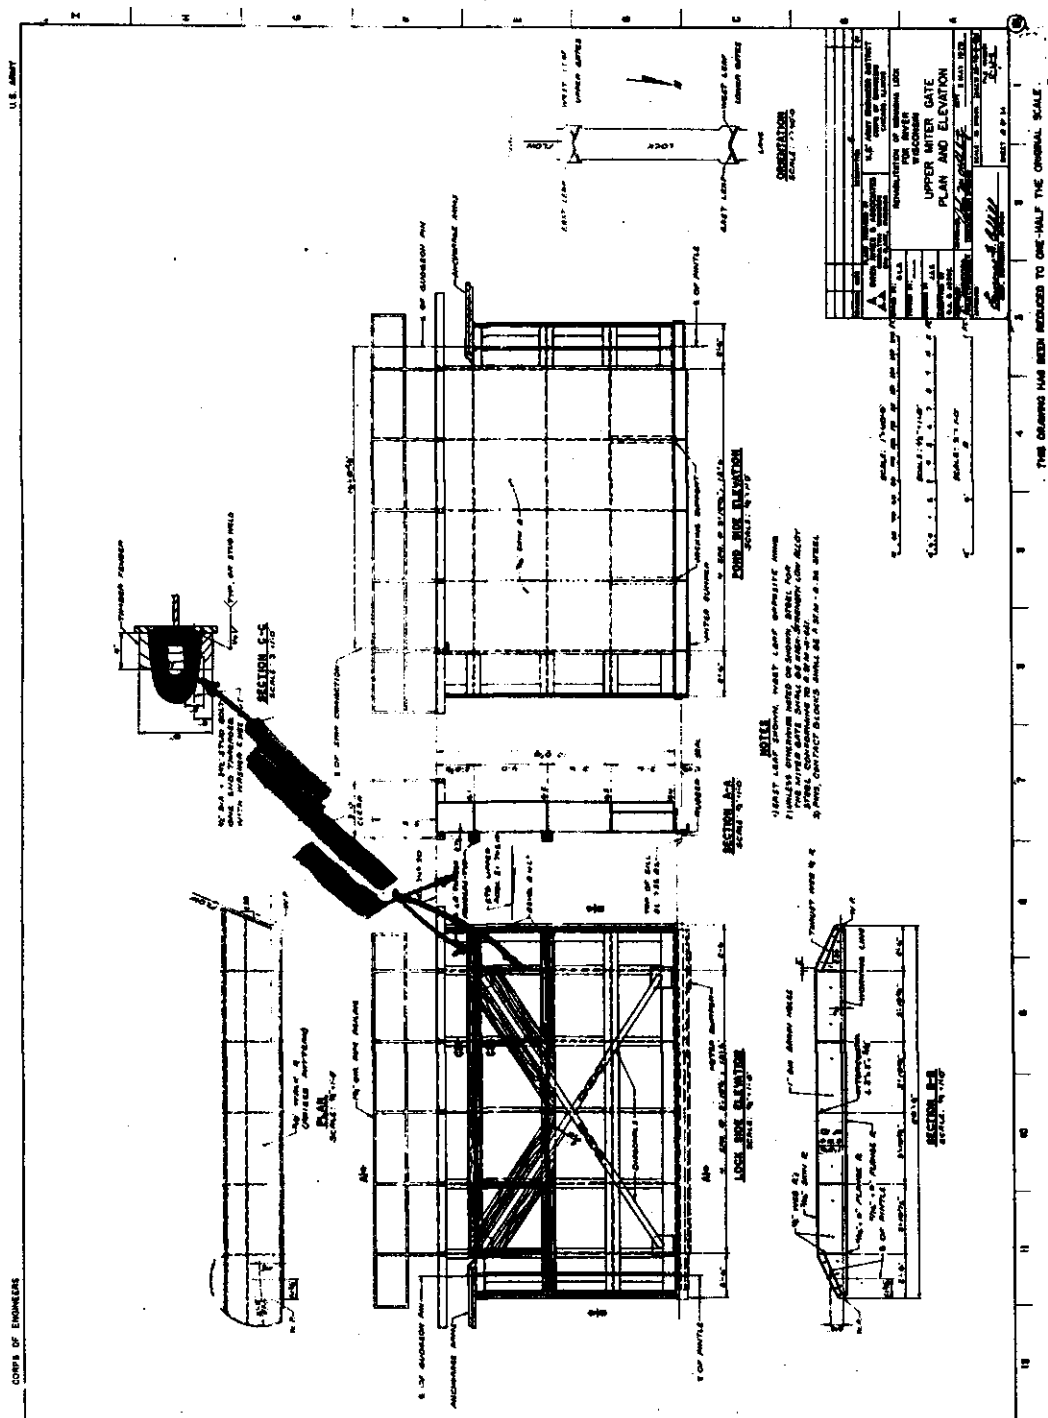
Photocopy of plans for Rehabilitation of Menasha Lock, Upper Miter Gate, Plan and Elevation, 1978, File #17-L1-9, sheet 18.

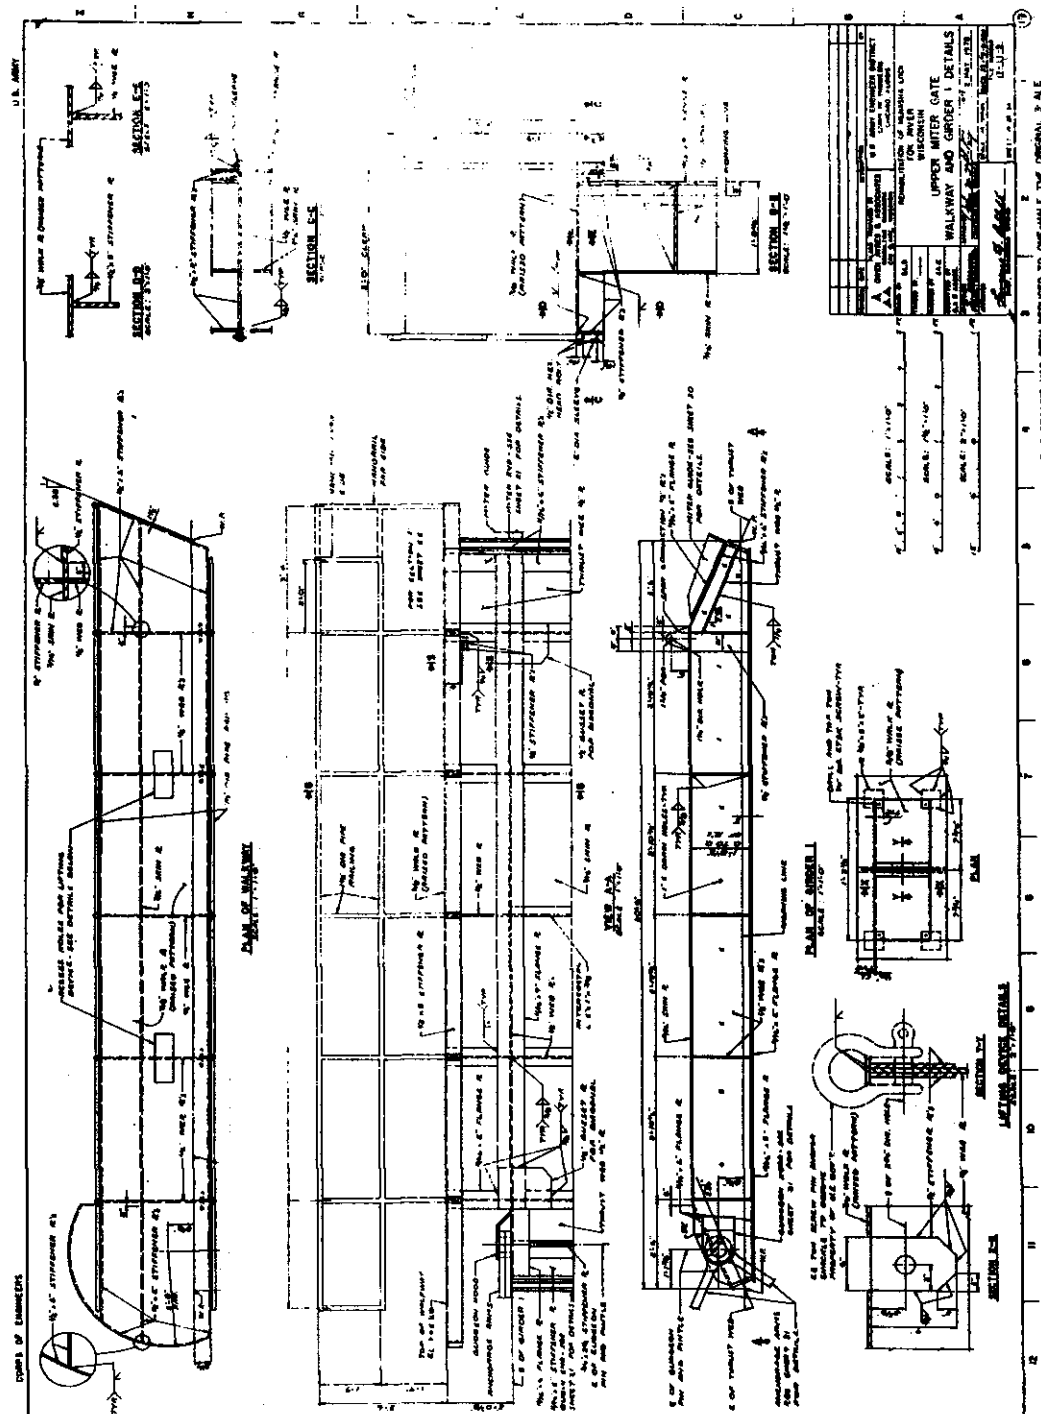
Photocopy of plans for Rehabilitation of Menasha Lock, Upper Miter Gate, Walkway and Girder 1 Details, 1978, File #17-L1-9, sheet 19.

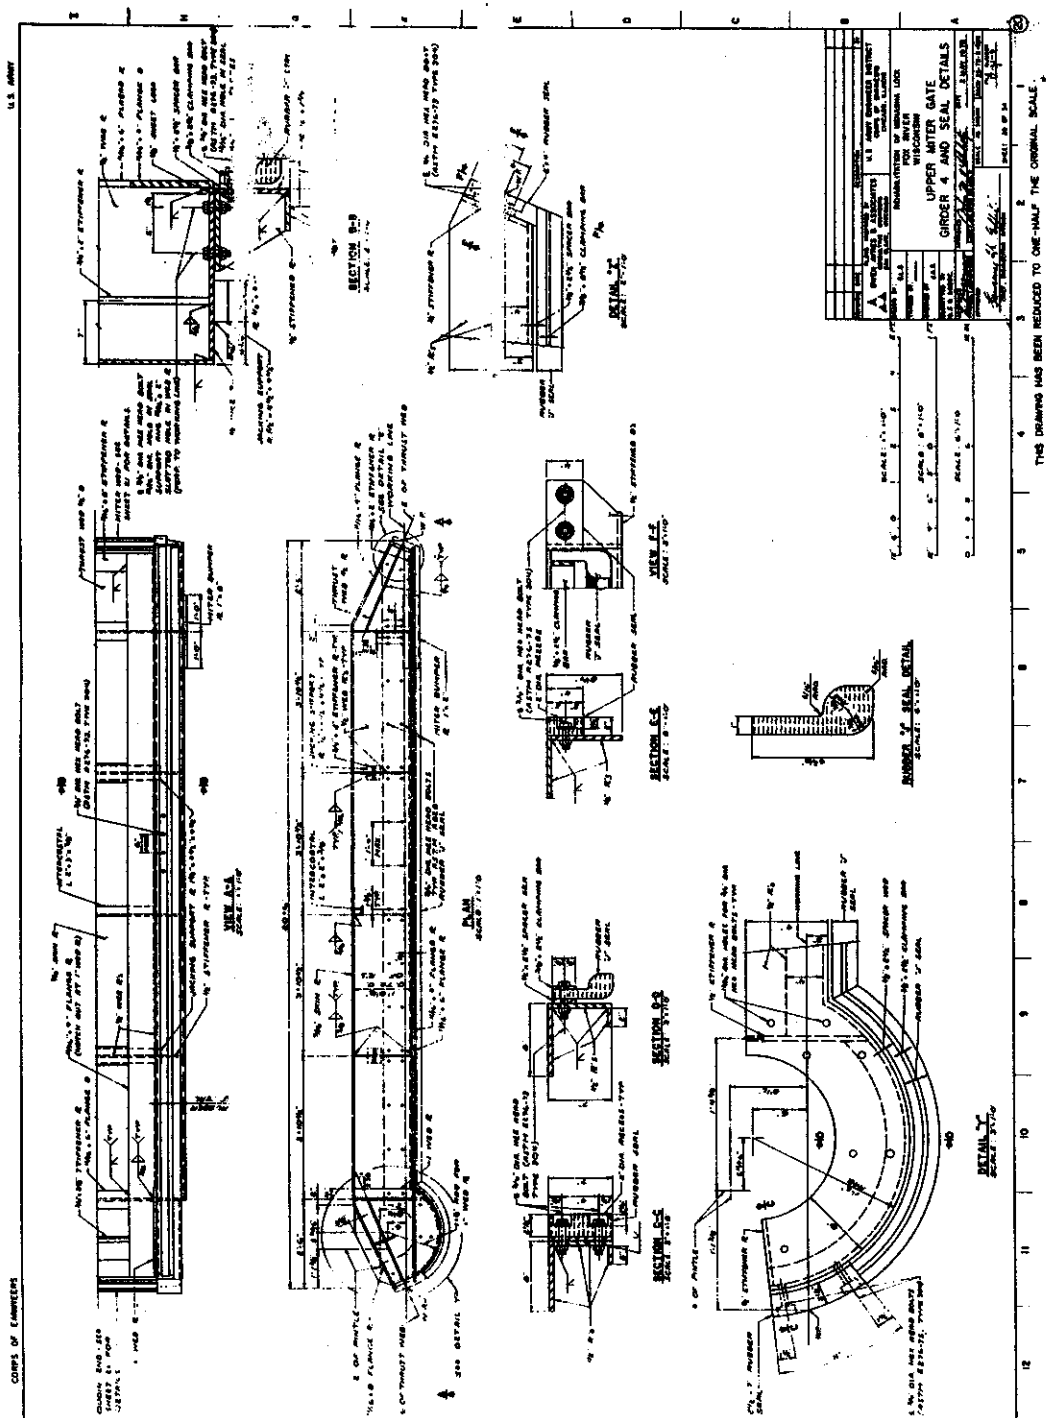
Photocopy of plans for Rehabilitation of Menasha Lock, Upper Miter Gate, Girder 4 and Seal Details, 1978, File #17-L1-9, sheet 20.
